Docket No. 217 – Development and Management Plan Inspection

Northeast Utilities Service Company Certificate of Environmental Compatibility and Public Need for the construction of a 345-kV electric transmission line and reconstruction of an existing 115-kV electric transmission line between Connecticut Light and Power Company's Plumtree Substation in Bethel, through the towns of Redding, Weston, and Wilton, and to the Norwalk Substation in Norwalk, Connecticut.

Date: June 18, 2004

Location: Norwalk Substation Expansion

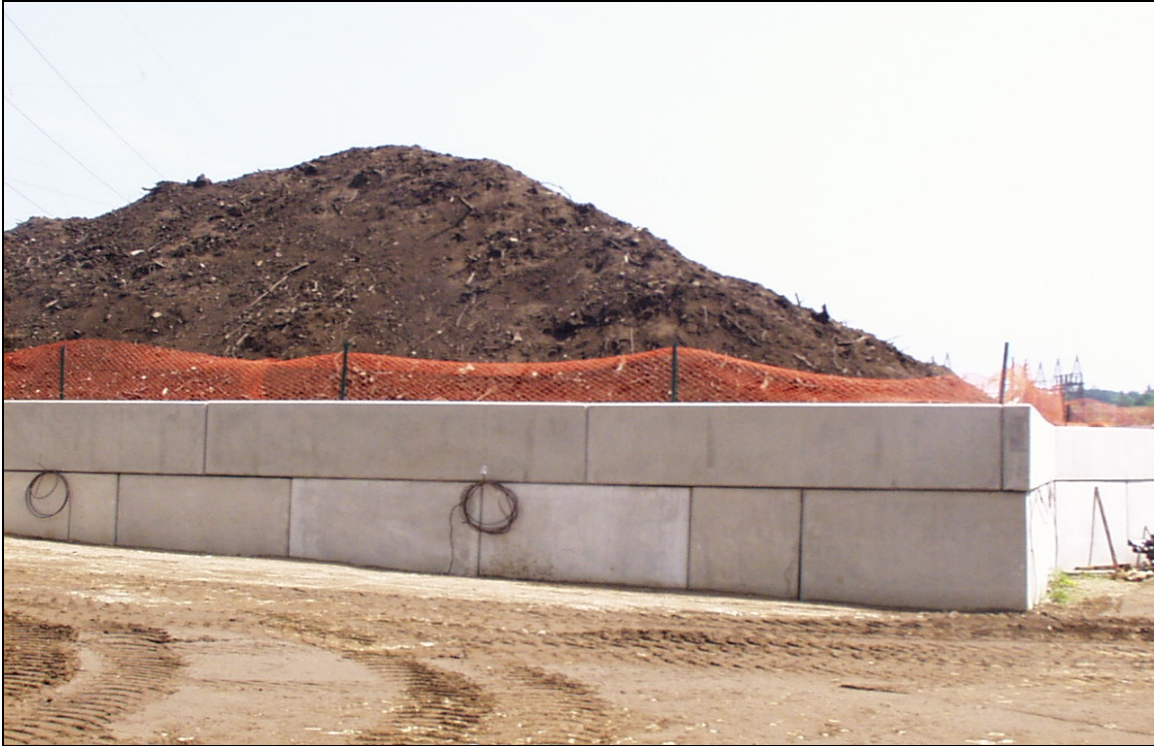
- The topsoil stockpile has been completely moved from its original location to within a corner of retaining walls #1 and 2 towards the center of site. 6/18/04	- The pile is well contained and will continue to be used where necessary in areas to be grassed in the future. 6/18/04

The topsoil stockpile has been relocated to an area within retaining walls #1 and 2 and will continue to be utilized in areas that will be grassed. The pile is well contained. 6/18/04

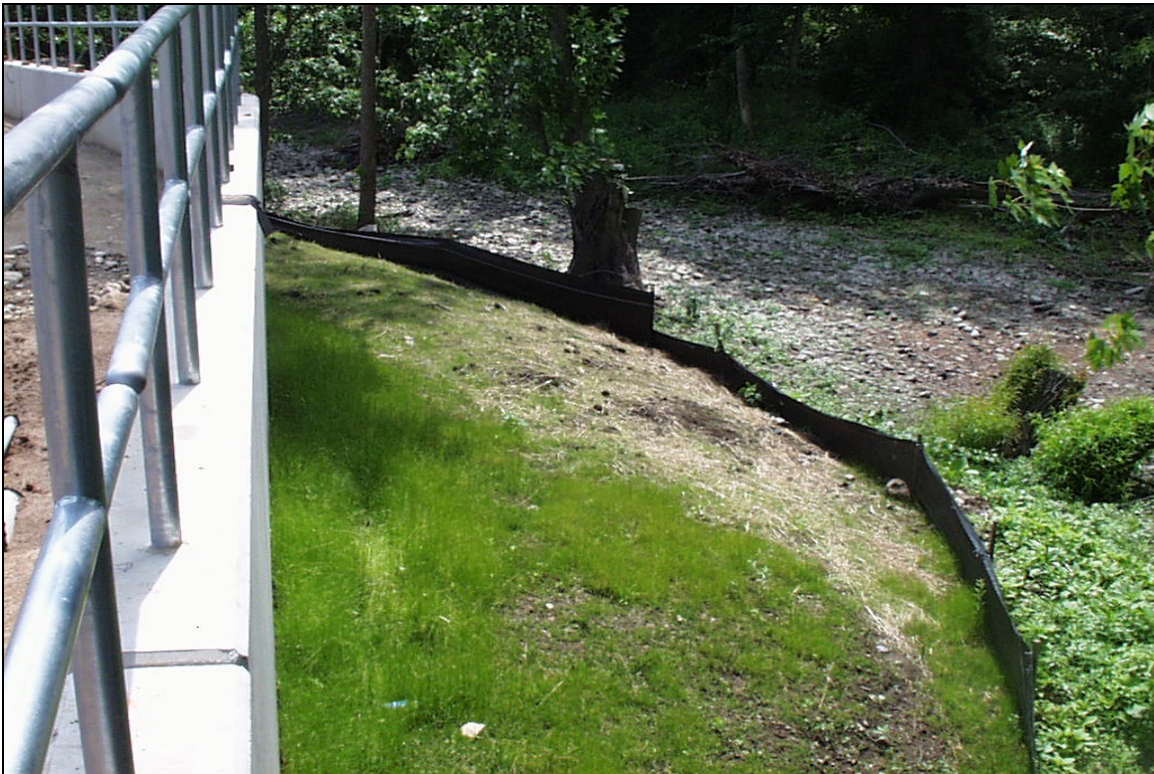
Areas of Inspection	Observation	Recommended Action
State species of concern, threatened and endangered species	- No species of concern are located in this area of construction.	- N/A
Vegetative clearing limits (including trees to save or danger trees noted)	<p>- The recently repaired scoured area below wall #5 is experiencing growth of grass cover. 6/10-6/18/04</p> <p>- Natural vegetation continues to come in very well along the riverbank, on both sides of the silt fence. 6/18/04</p>	<p>- The area will be monitored for cover. Future observations may find that a more significant root structure is needed here. 5/27-6/18/04</p> <p>- None at this time. If any areas still look sparse, some seed could be scattered. 6/18/04</p>
Dewatering	- Dewatering activities are complete at this time.	- No actions required at this time.
Blasting	- No blasting is occurring on site at this time and it is not anticipated to be necessary.	- None at this time.

View along wall #5 where the previously scoured area was located. Vegetative growth is coming in well following the repairs. 6/18/04

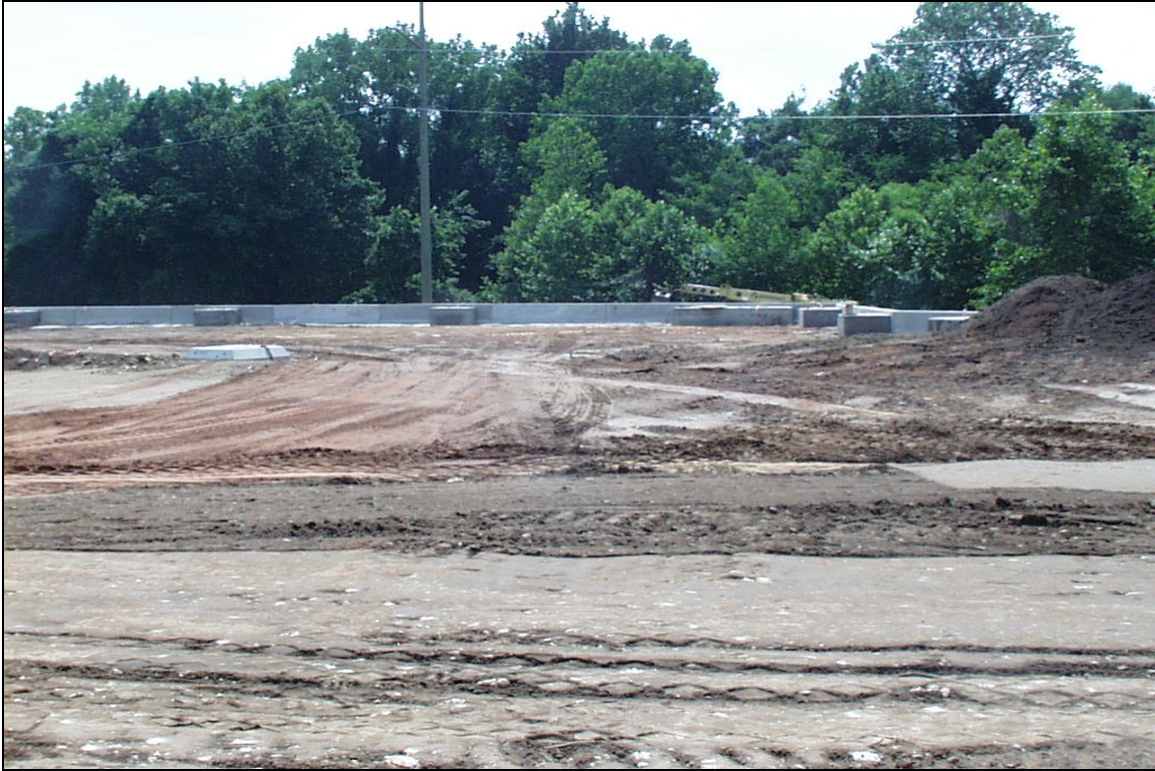
- The area to the east of walls #1 and #2 is being brought to grade with fill and is almost level with the top of the wall in some locations. 6/18/04	- All soil is well contained within the walls towards the center of the site. 6/18/04

View of the fill area near wall 1 where the area is being brought to grade. All soil is well contained. 6/18/04

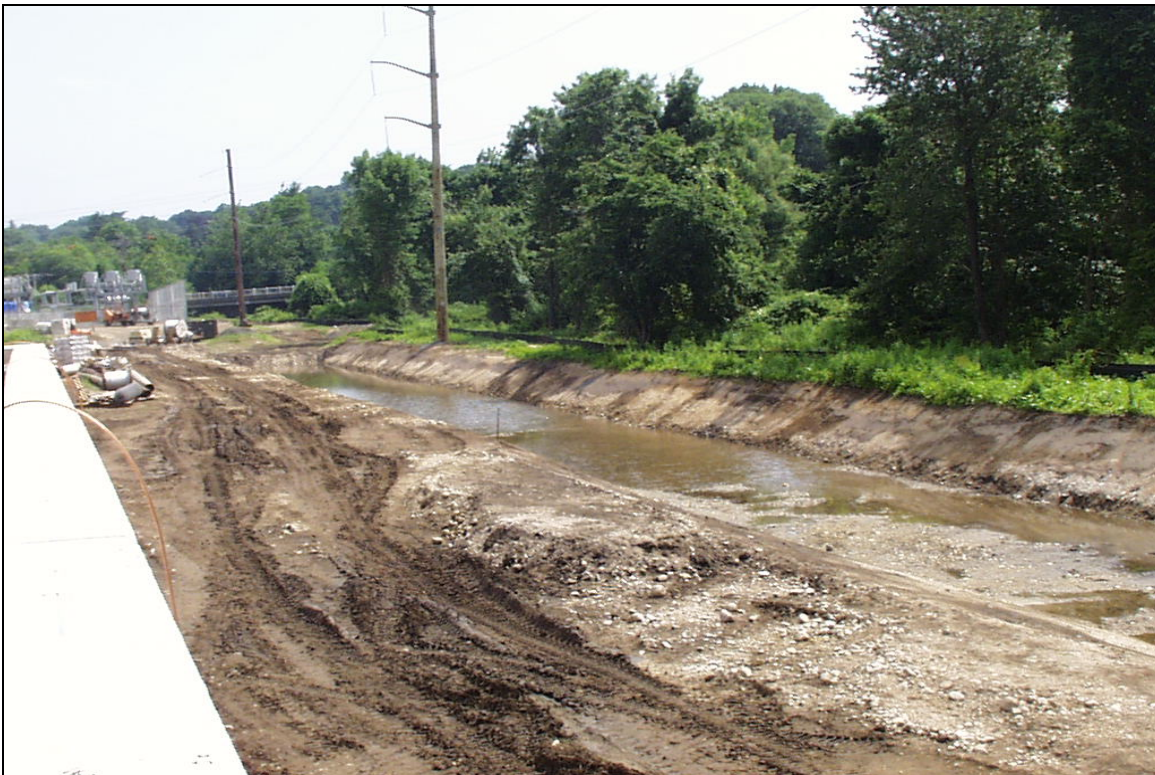
Areas of Inspection	Observation	Recommended Action
	<ul style="list-style-type: none"> - Work had begun on the overflow channel and portions of the sediment basin had been excavated for this purpose, as well as the area where the stockpile was previously located. 6/18/04 	<ul style="list-style-type: none"> - The channel has not been extended to the river at this time and it was stable and contained. 6/18/04
	<ul style="list-style-type: none"> - Grass is coming in well in the area below wall 5 which had recently been placed with stone, topsoil, seed and mulch. 6/10-6/18/04 	<ul style="list-style-type: none"> -Continue to monitor for sufficient vegetative growth and future stabilization. 6/10-6/18/04
<p>Inland Wetland and Watercourse encroachment and mitigation</p>	<ul style="list-style-type: none"> - The silt fence is still well in place along the river. One spot had been removed for channel work but was being replaced for the weekend. 6/18/04 - The overflow channel is under construction/excavation at this time but has not been extended to the river yet. Cobblestones and a liner will be installed, as well as a center swale. 6/18/04 - Sheet piling cofferdams are being installed in the dry, natural channel bed area near the waters edge. -The pump had been brought back into the yard and was not active/needed at this time. 6/18/04 - A grate will be installed on the existing outlet on wall #5 for safety and to prevent debris from entering 5/27-6/18/04 	<ul style="list-style-type: none"> - Continue to monitor silt fence and repair as necessary, especially in portions closest to the river. - Final verbal DEP approval to use sheet piling in place of originally proposed sandbags in this area was given 6/21/04 - The area is well under control with little disturbed soil. - Continue to use secondary containments when the pump is necessary.

View of portions of the overflow channel under construction where the original sediment basin has been excavated. 6/18/04

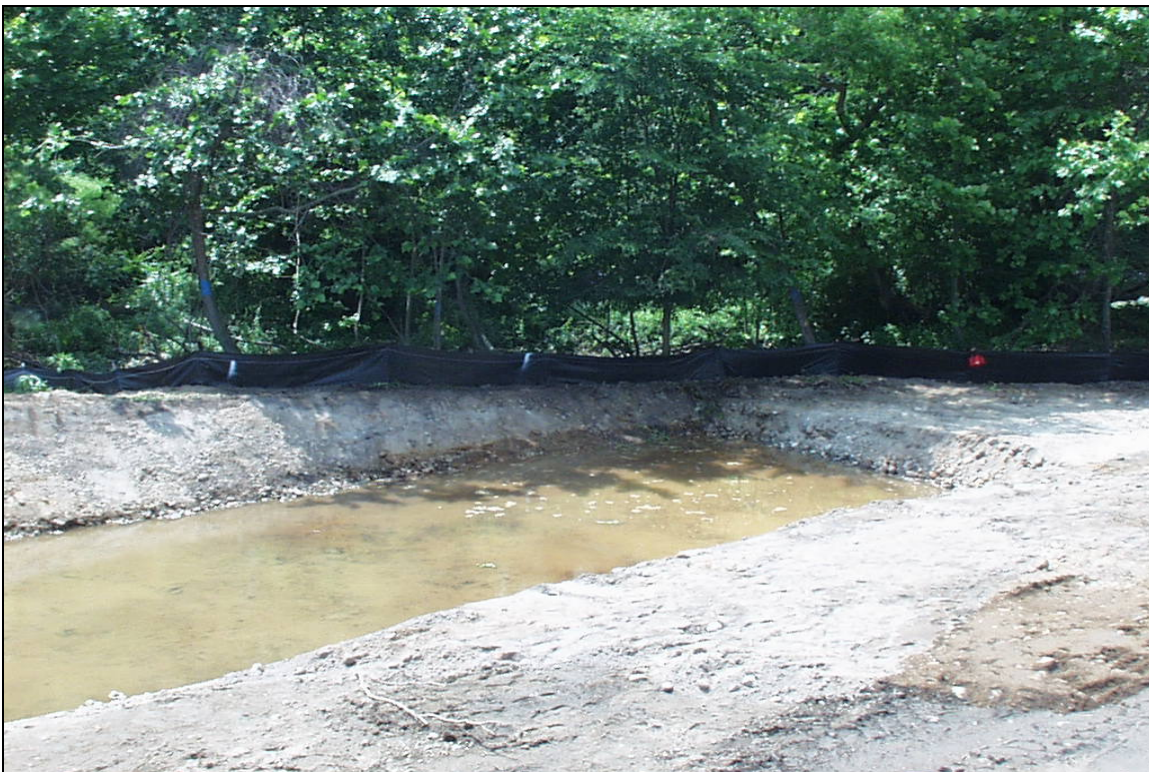
View of the overflow channel. The excavation had continued from the original basin to where portions of the stockpile had originally been. 6/18/04

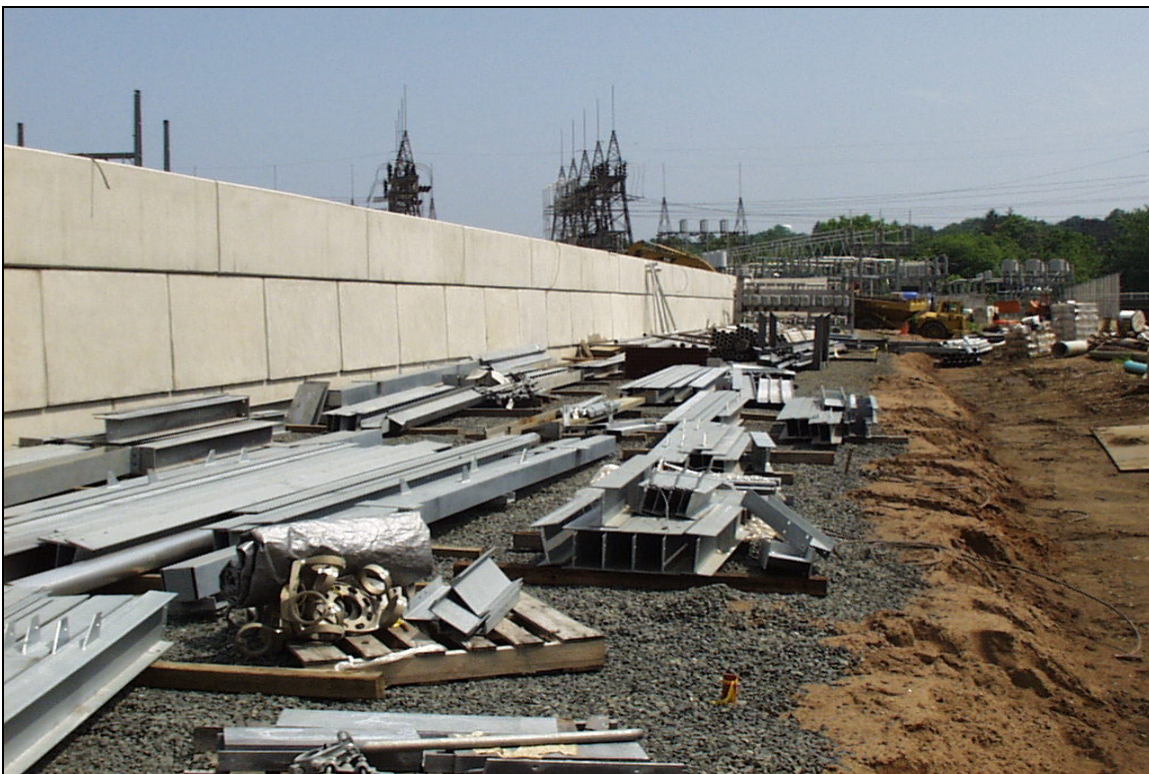
View of the storage area near walls #1 and 2. 6/18/04

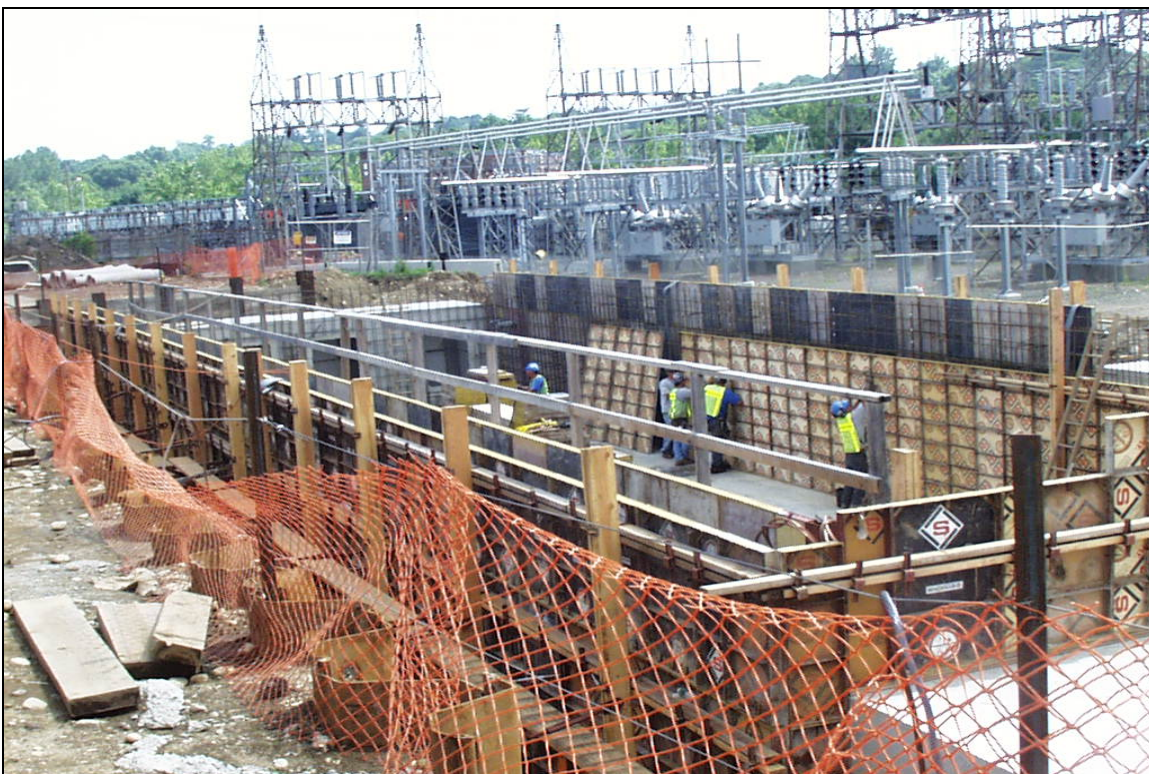
View of the continuing construction at the control building. 6/18/04

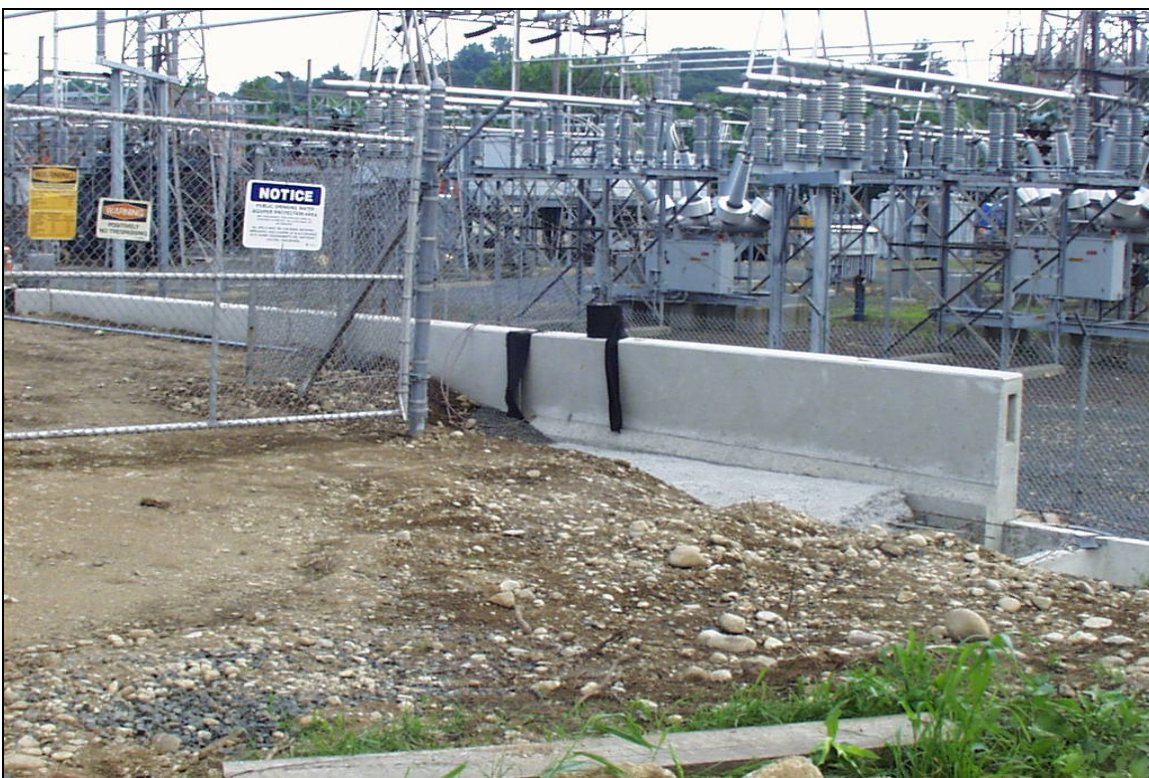
View of wall #3 under construction near the control building. 6/18/04
